HARRINGTON SQUARE ARCHAEOLOGICAL IMPACT ASSESSMENT FOR PHASE 1 HIA

HWC25061013

submitted in terms of Section 38(4) of the NHRA (1999) for proposed redevelopment of Harrington Square, bounded by Harrington, Caledon & Canterbury Streets, Cape Town

Prepared by Rennie Scurr Adendorff Architects for Infinity Environmental on behalf of the City of Cape Town

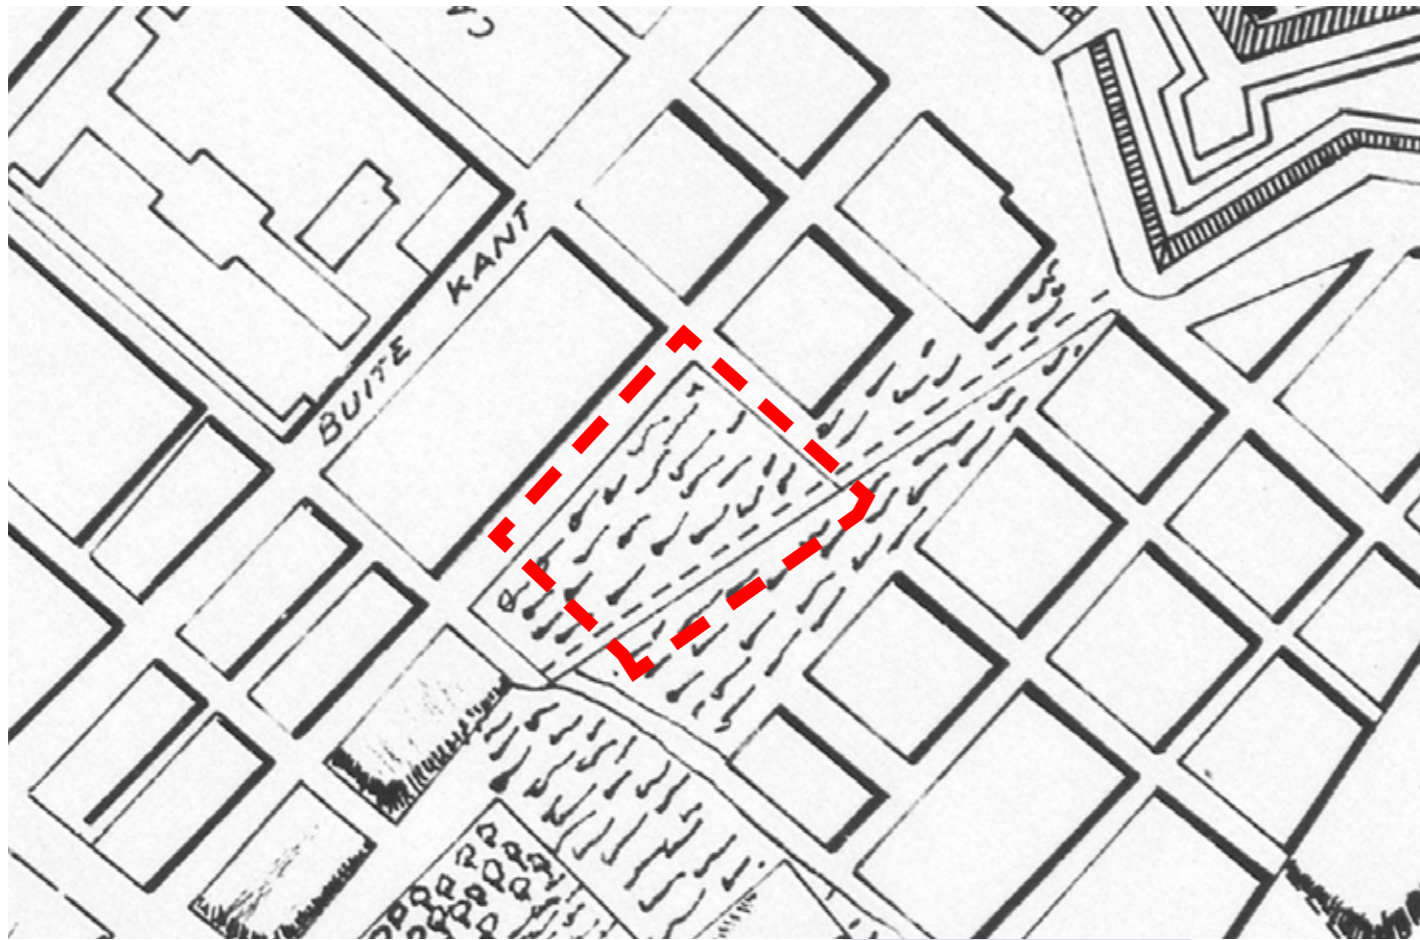
Figure 8. The 1811 Eleman's Map of Cape Town, showing the site as open ground, surrounded by plots earmarked for development; the Capelsloot is indicated along the south east of the site, flowing into the Castle moat

In the C19th, the Capelsloot was filled in and replaced with a barrel drain, opening up that land to development. This system was initially depicted in an early C19th plan by Thibault, and the Eleman plan of 1818 shows the grid layout as it was later developed, while the Thomson plan of 1827 shows the canal still in place, running east of the newly built Roman Catholic Church (see Section 3.3 below). By 1860 the drain ran down Canterbury Street, and is indicated as covered north of Constitution Street.

- Figure 8. The 1811 Elemans Map of Cape Town, showing the site as open ground, surrounded by plots earmarked for development; the Capelsloot is indicated along the south east of the site, flowing into the Castle moat

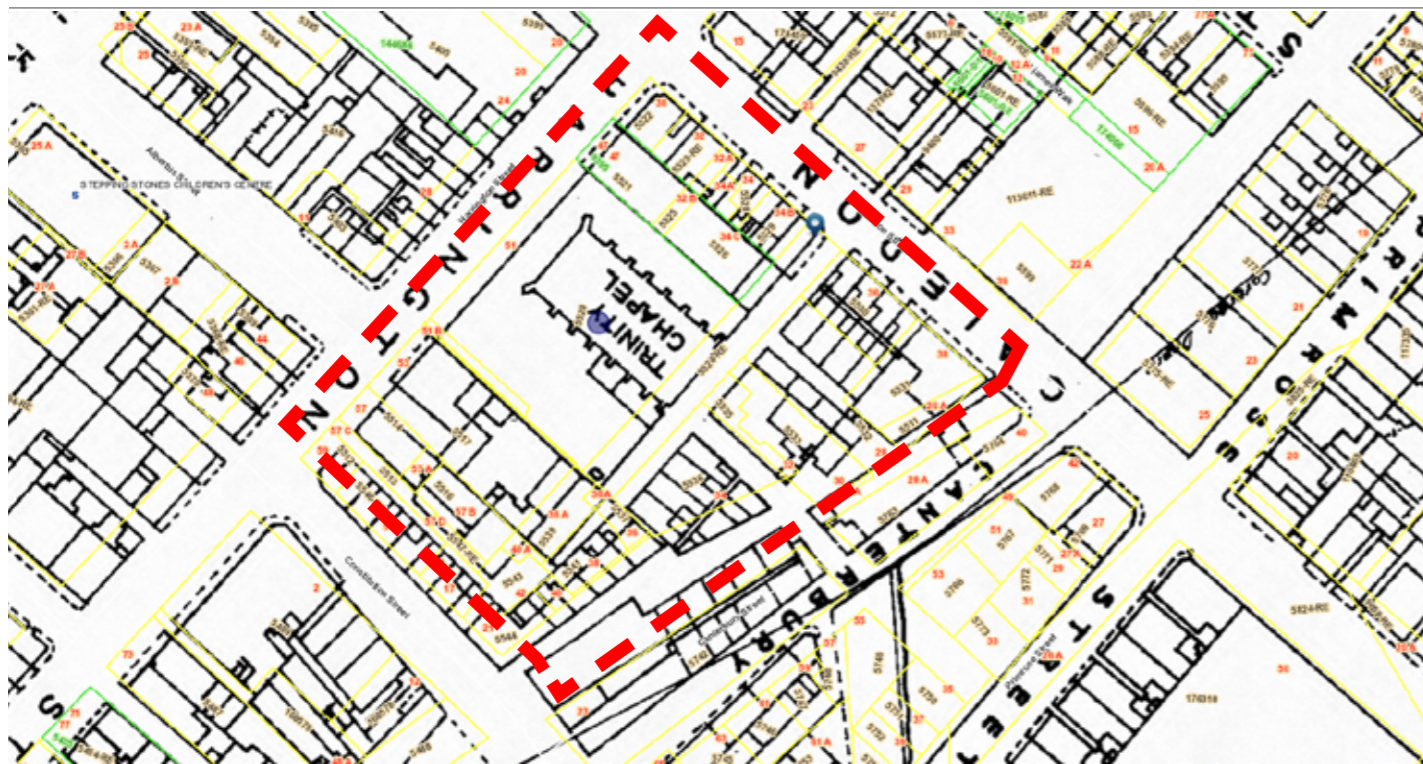
Figure 12. 1862 - Snow Map showing dense development around the site of the Trinity Chapel (CoCT EGSViewer, 2026)

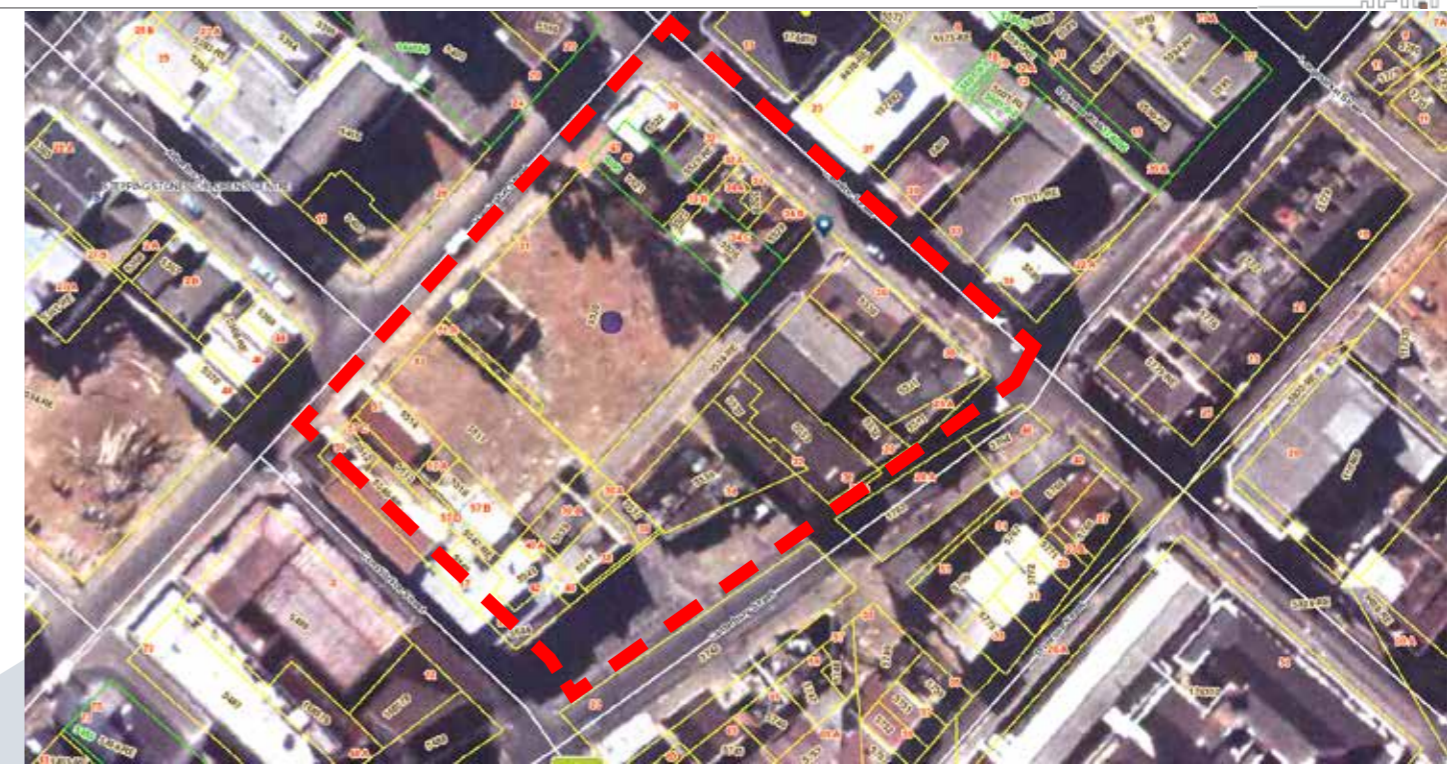
Figure 14. 1971 Aerial image showing demolitions on site, and in the surrounding areas underway (CoCT EGSViewer, 2026)

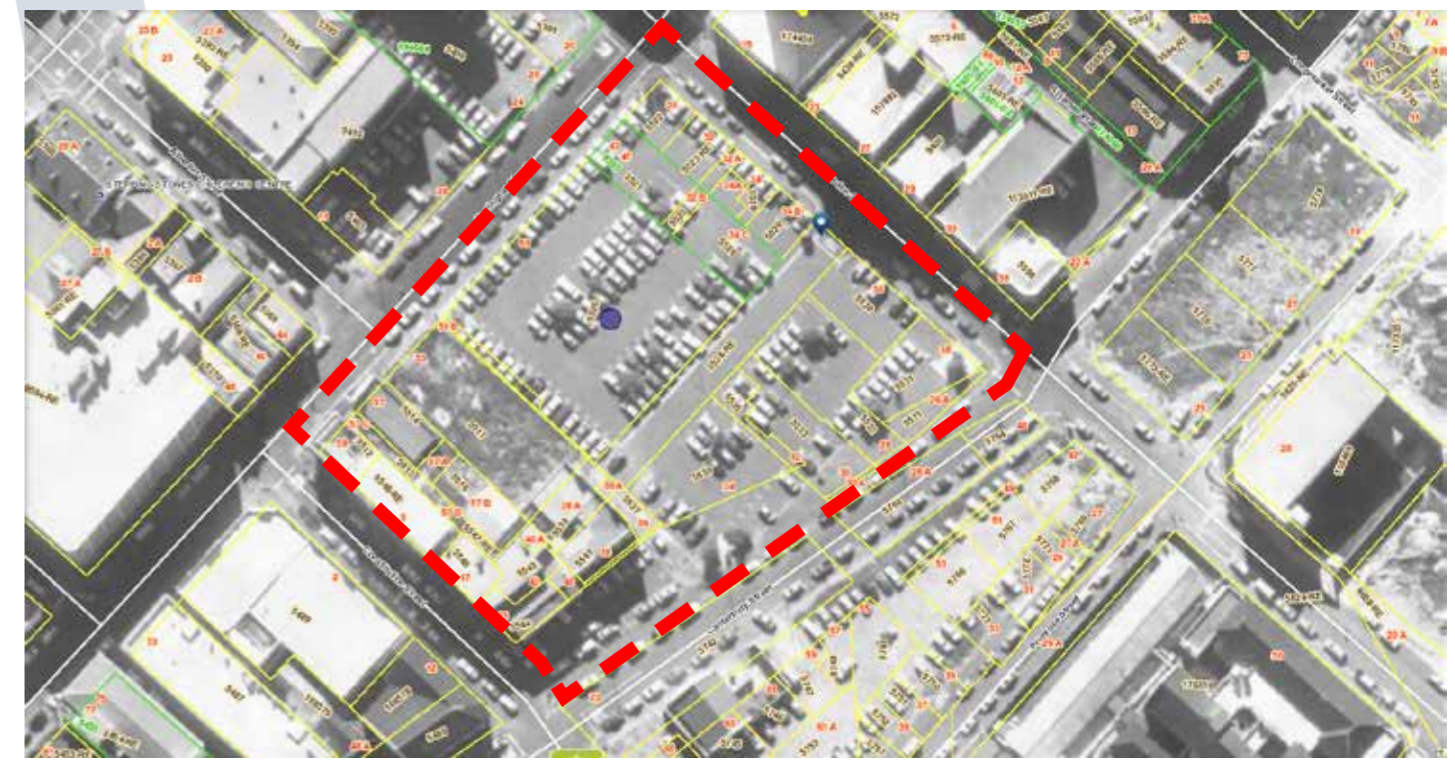
Figure 15. 1980 Aerial image showing the site largely in its current form, given over to parking (CoCT EGSViewer, 2026)

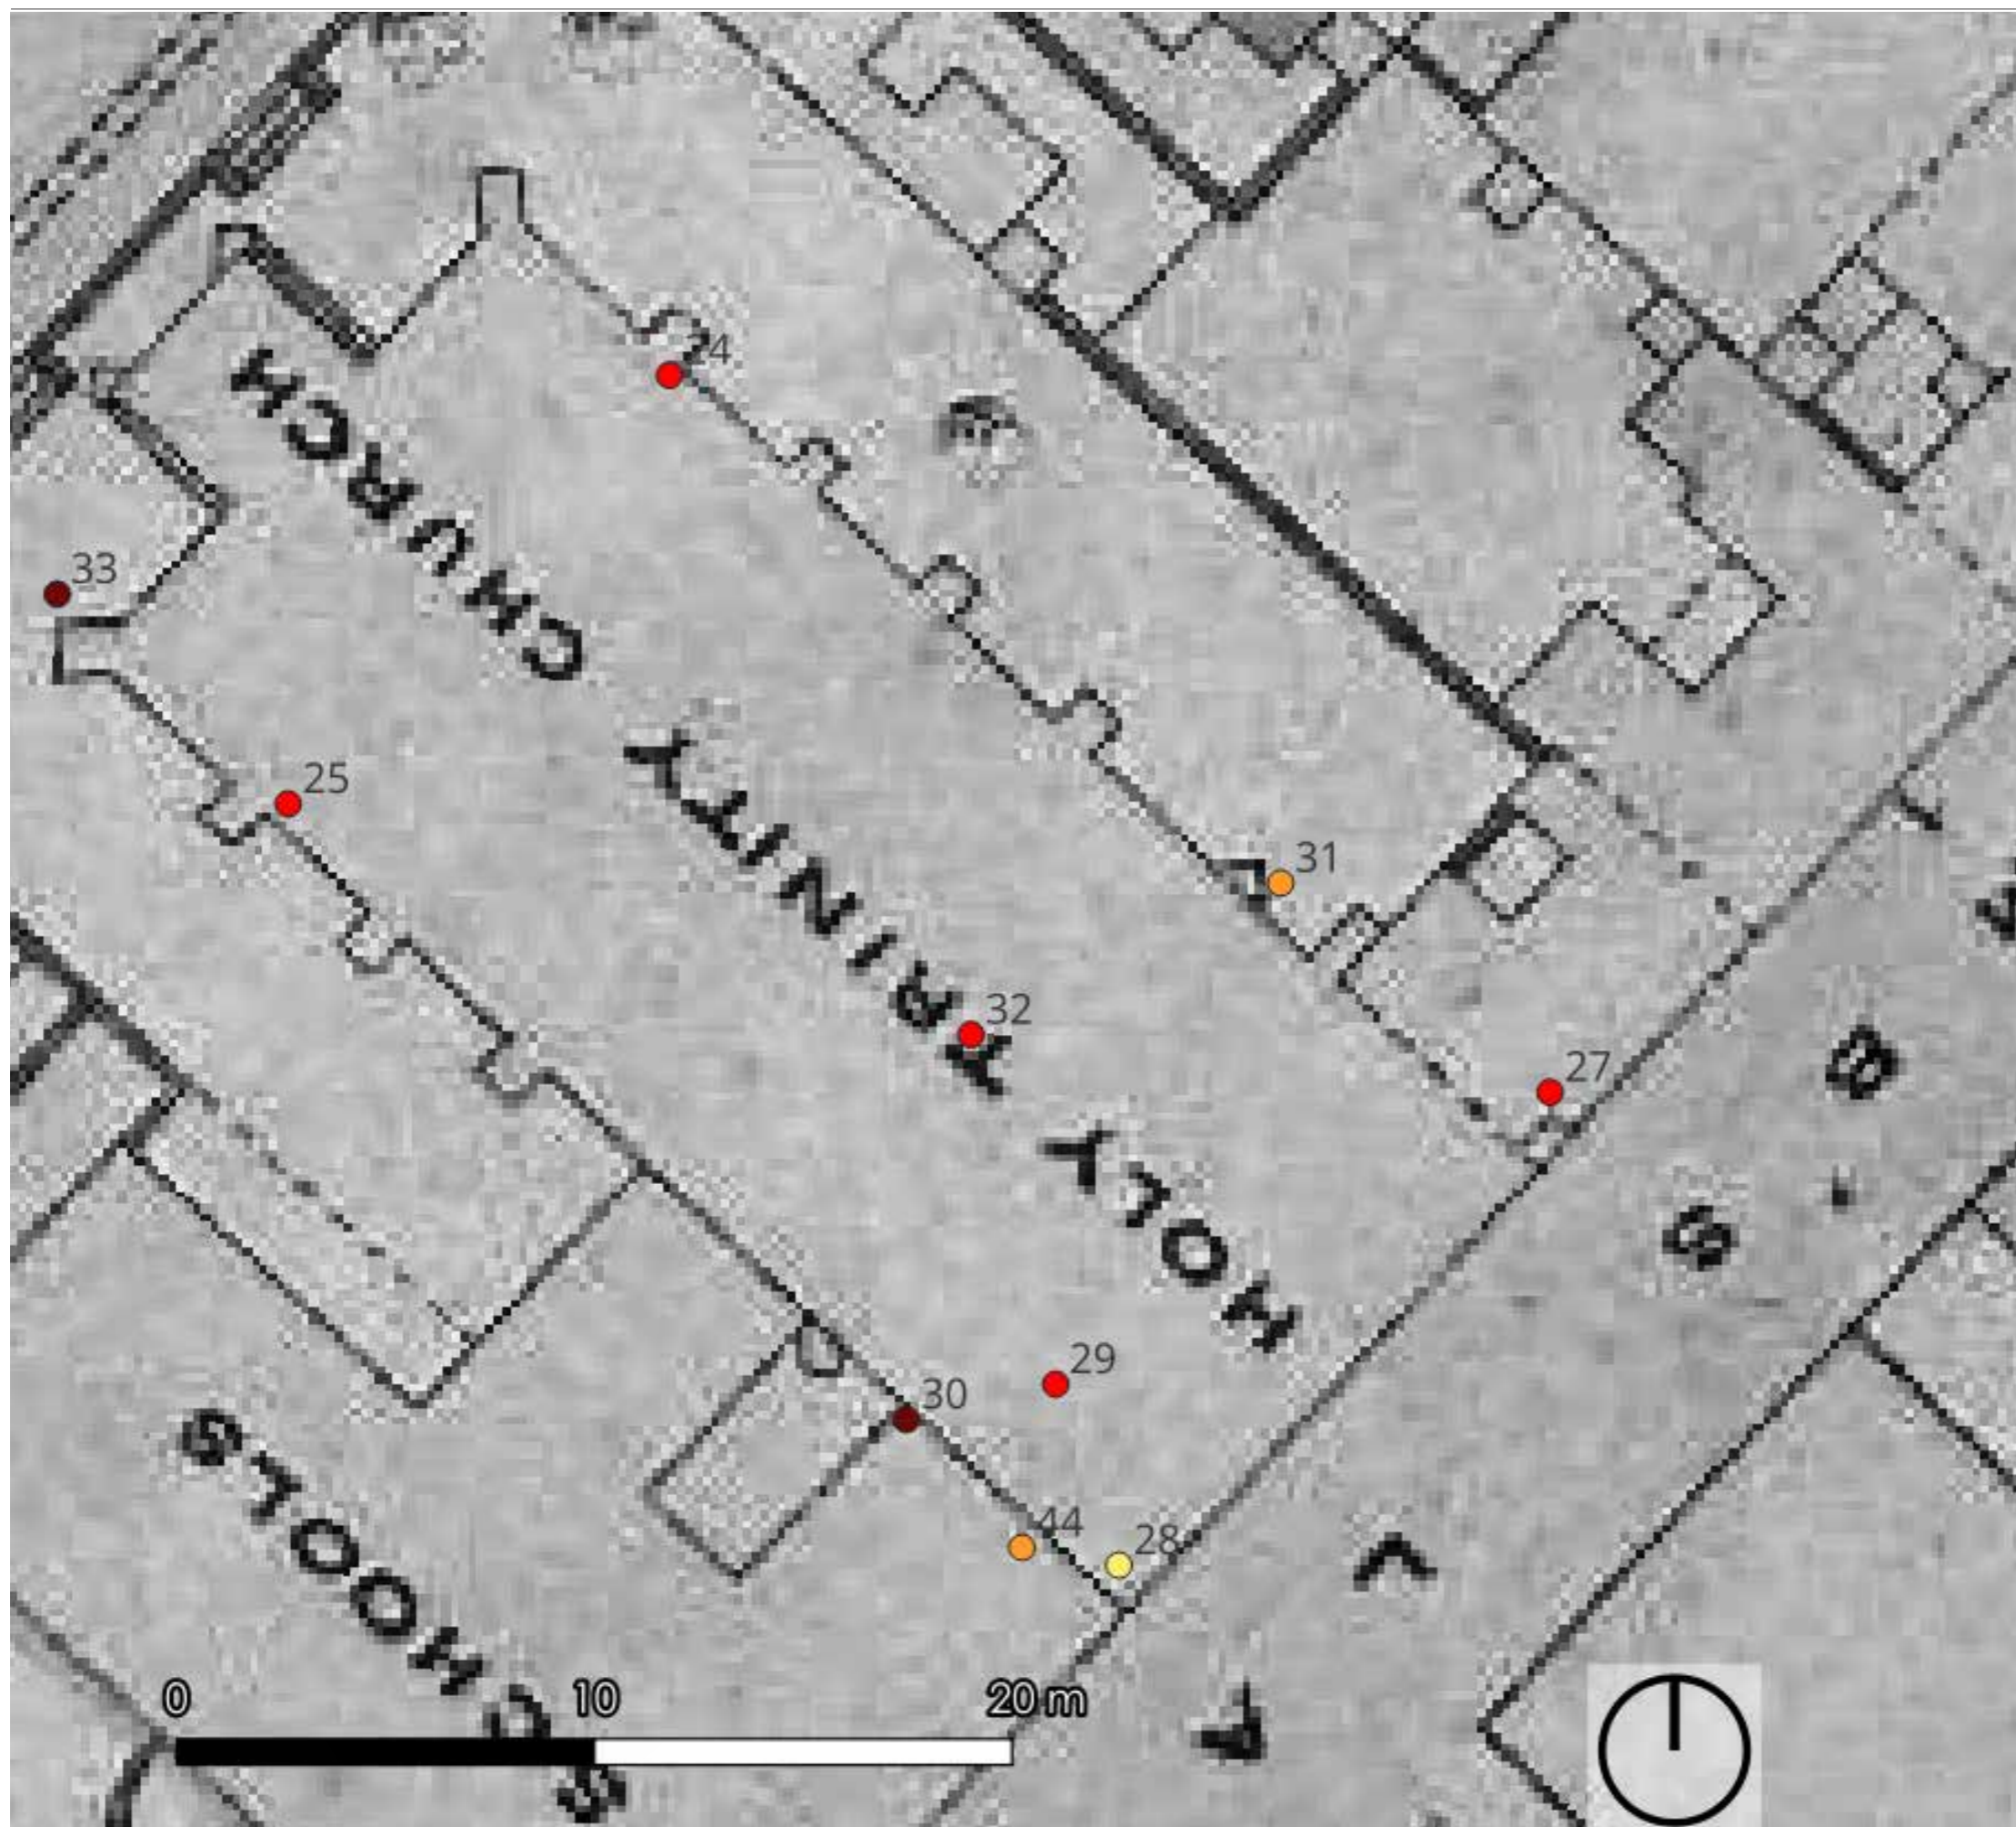
KEY	
TGT_24:	3 anomalies 0.5m to 2.5m deep 3m wide
TGT_31	0.6m to 2m deep 4m wide
TGT_27	2 anomalies 1.1m to 2.5m deep
TGT_28	2 anomalies 1m deep
TGT_44	0.86m to 1.5m deep 2m wide
TGT_30	2.5m deep 4m wide
TGT_25	3 anomalies 0.5m to 2.5m deep
TGT_33	1.7m to 2.88m deep
TGT_29	0.58m to 2.47m deep 4m wide
TGT_32	1m to 2.5m deep 7m wide

Figure 18. Detail of the targets that intercept the Church location as mapped in 1895; details of each target, as provided in the GPRS report (UDS Civils, 2024) are provided in key at right (RSA, 2024)

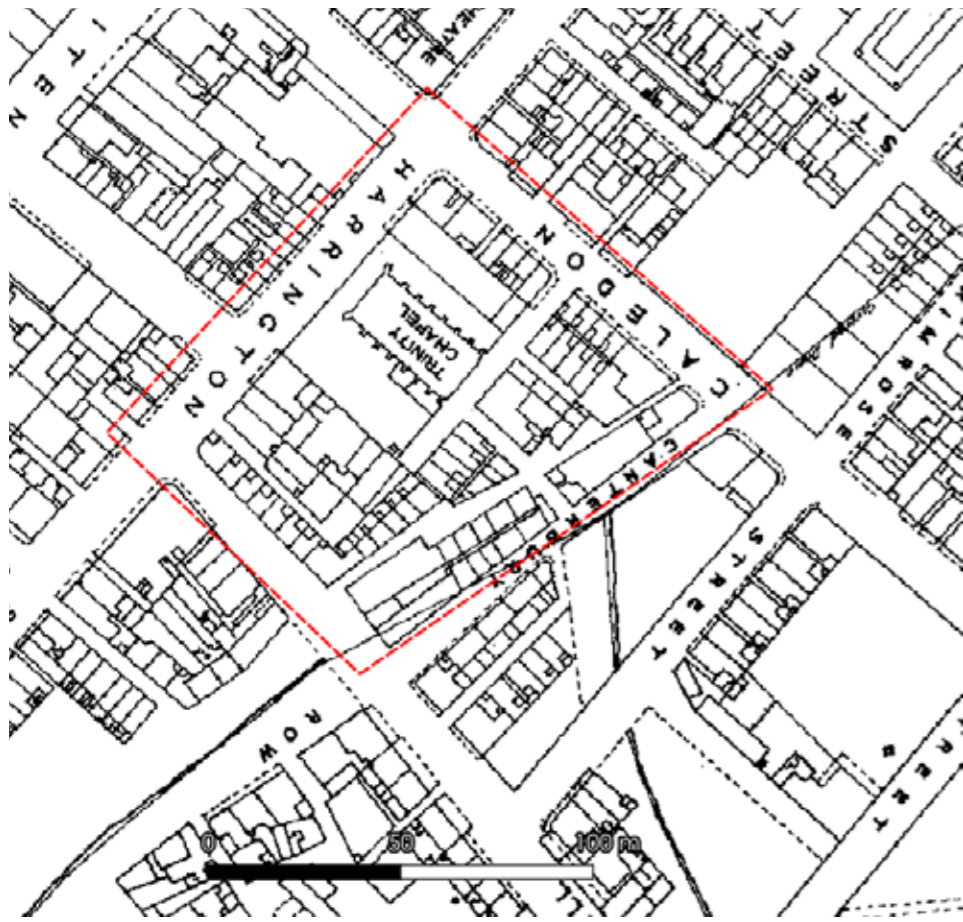
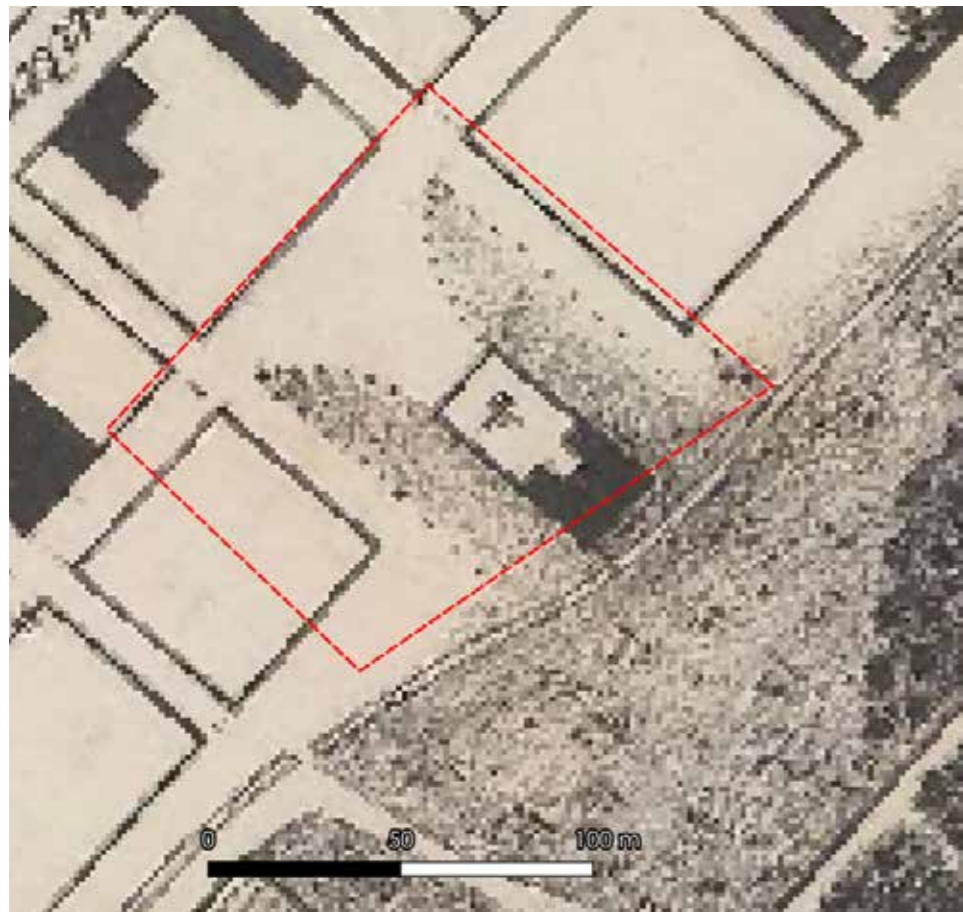
Figure 19. Thomson's map of 1827 (top) and Snow's survey of 1862 (above) showing the relative placement of the church and later chapel, and the alignment of the Capelsloot (RSA from CoCT EGSViewer, 2024)

Comparative mapping of the site is largely inconclusive as to the relationship between the earlier Roman Catholic Church building, and the later Holy Trinity Chapel. Thomson's 1827 survey shows the earlier Church on the eastern boundary of what is now Harrington Square, and abutting the Capelsloot, but also incorrectly maps the alignment of the Castle, casting some doubt on the accuracy of the depiction. Further, it is likely that the alignment of the open sloot would have shifted somewhat with floodwater and erosion. These factors notwithstanding, it is conceivable that later Church might have been built further from the sloot alignment to ensure greater stability.

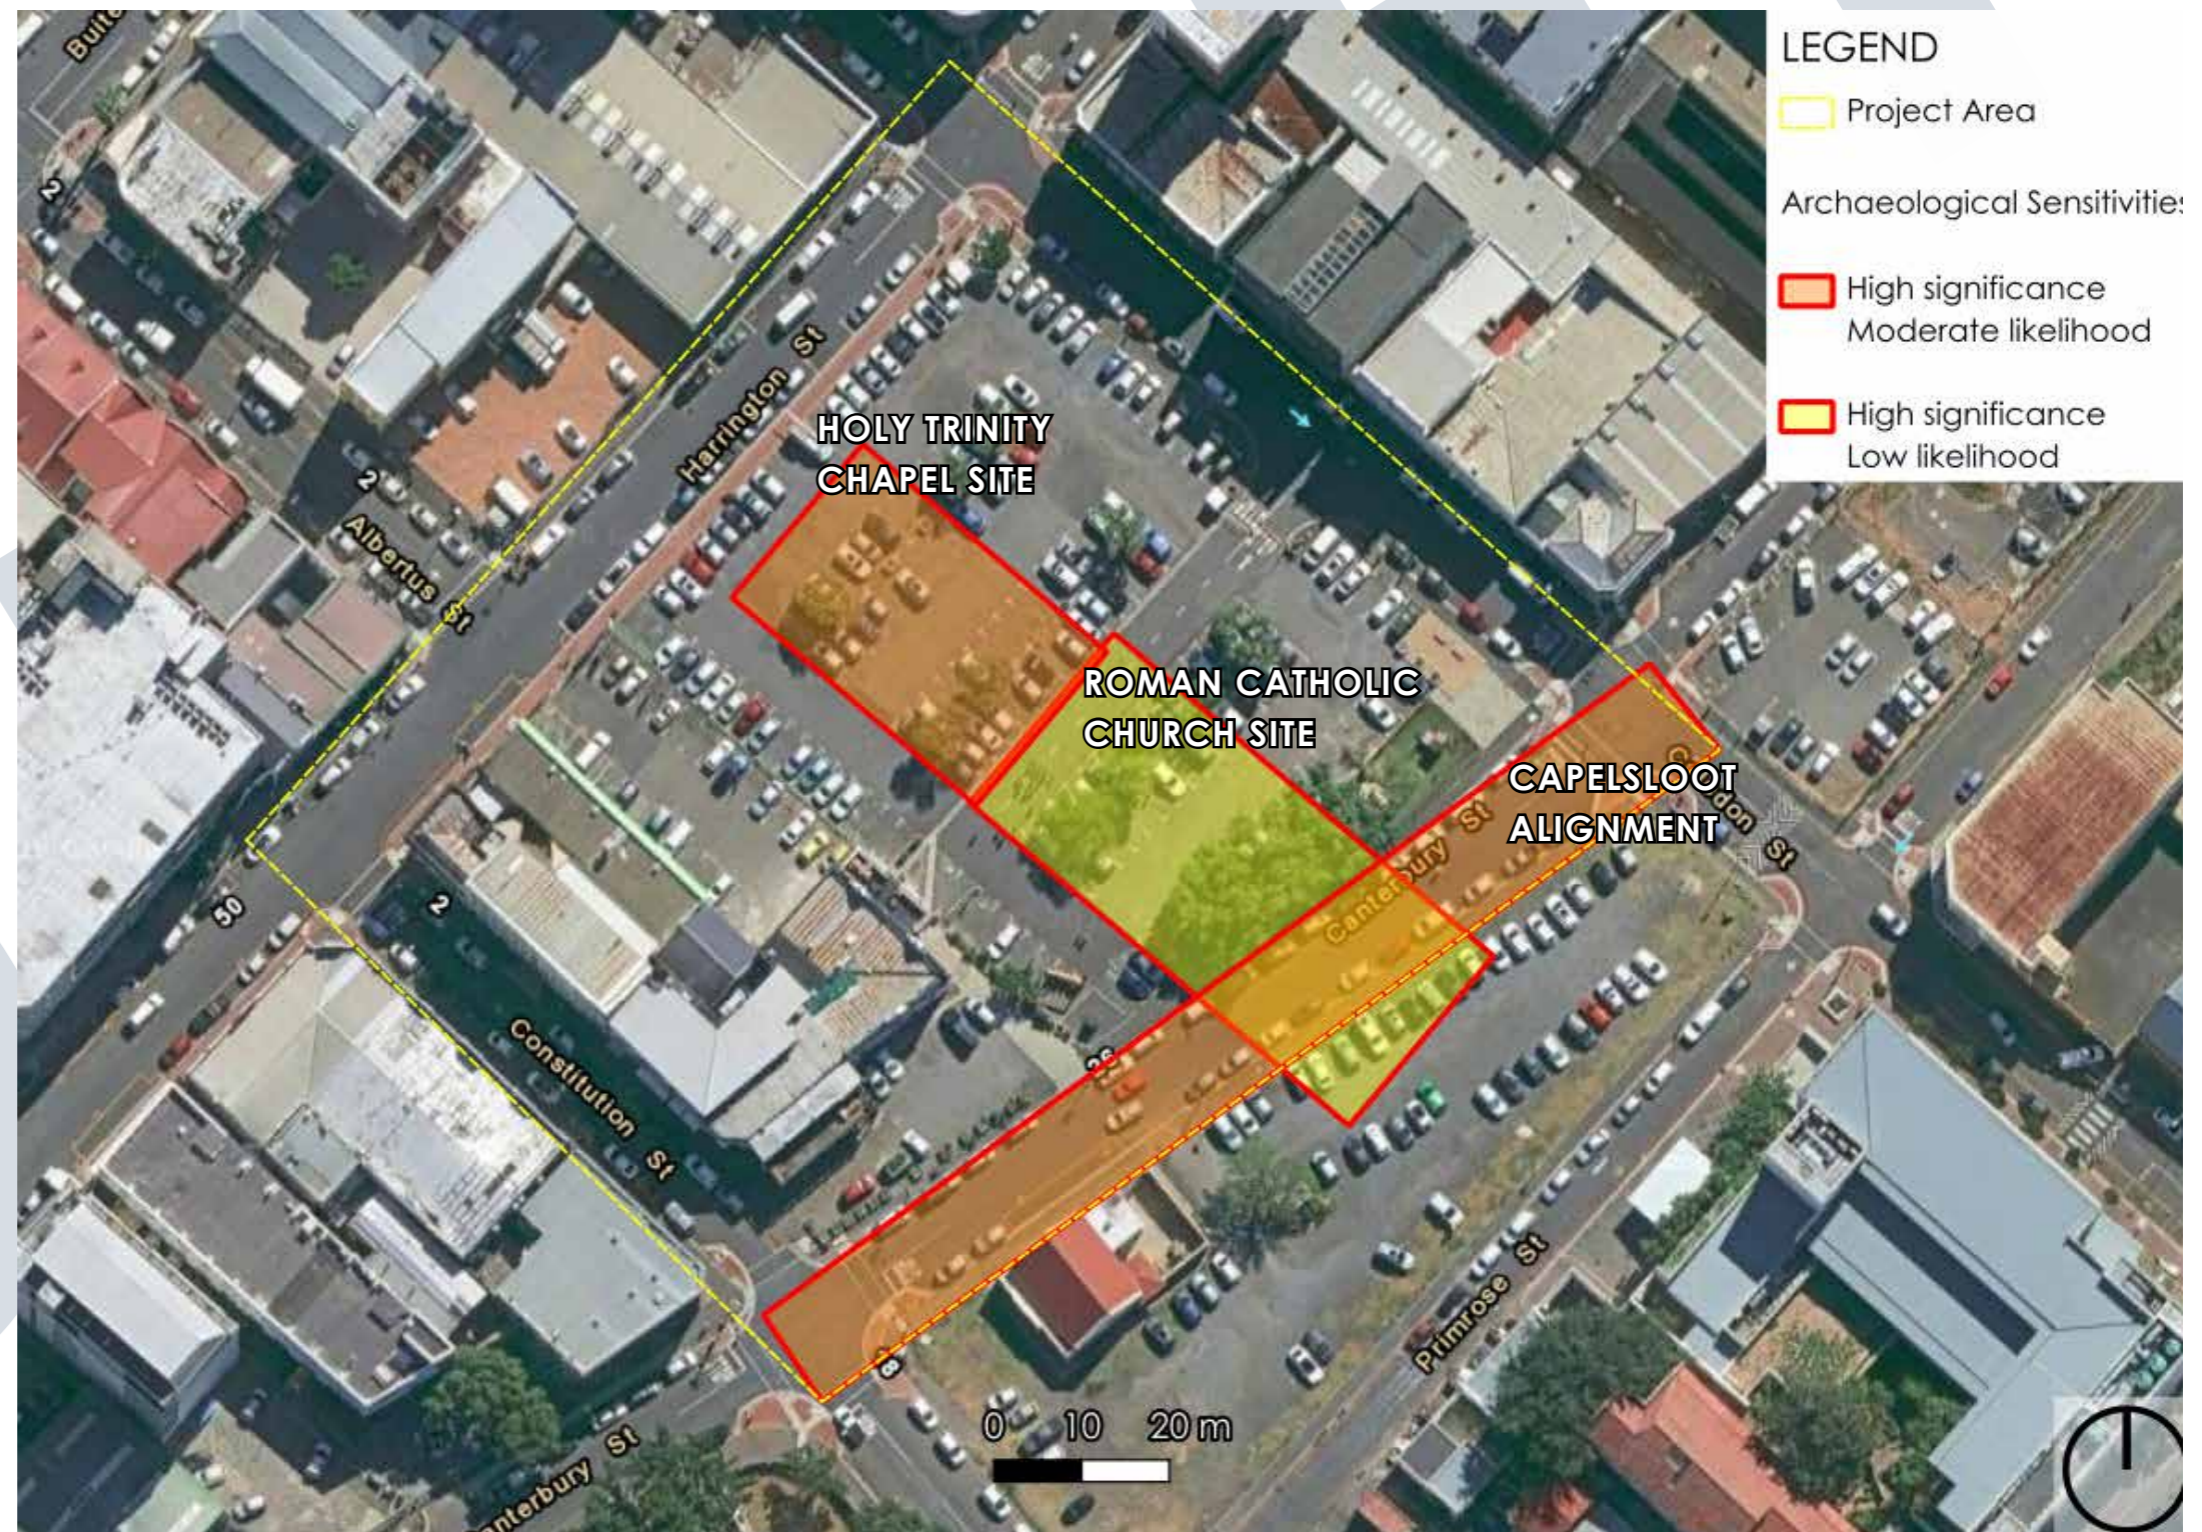
Figure 22. Archaeological sensitivities on site (RSA, 2026)

Should deep excavations be proposed, such as for basement parking, preliminary investigation of the affected area, if it intersects with any of these features, should be undertaken.

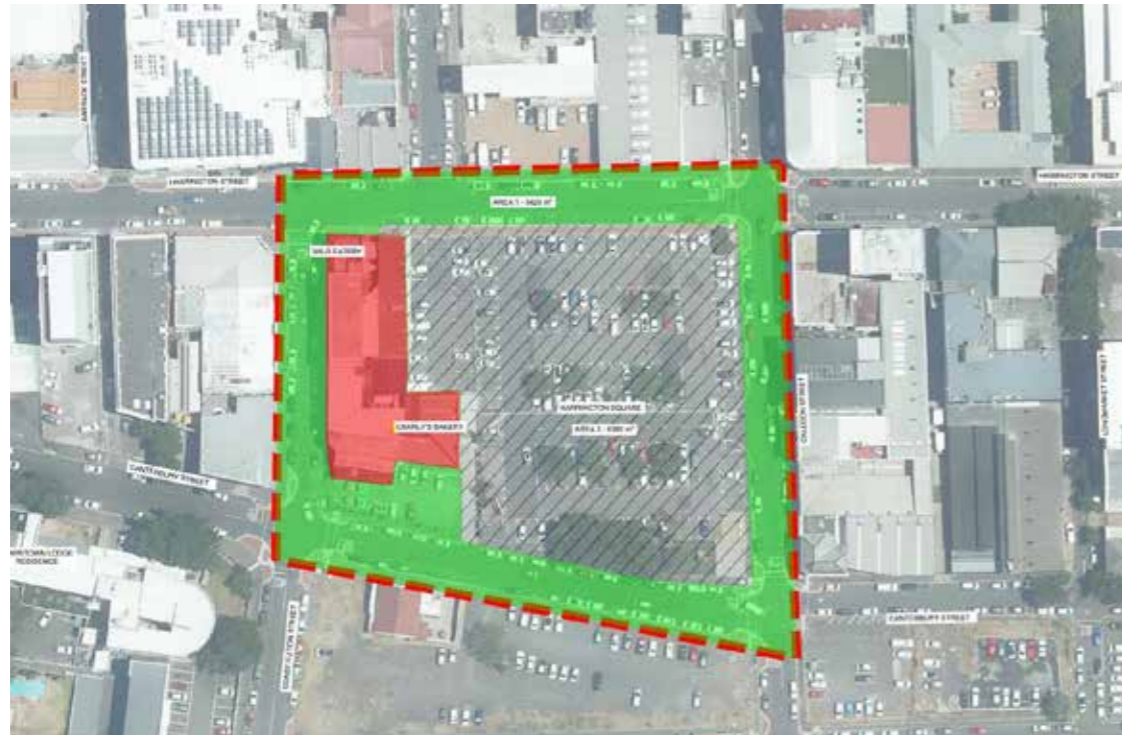
Anomaly's/ Archaeological Scans:

For example, TGT-01 (target number) can be found on the drawing. The corresponding report, identified as Grid1: TGT-01, can be found within this document.

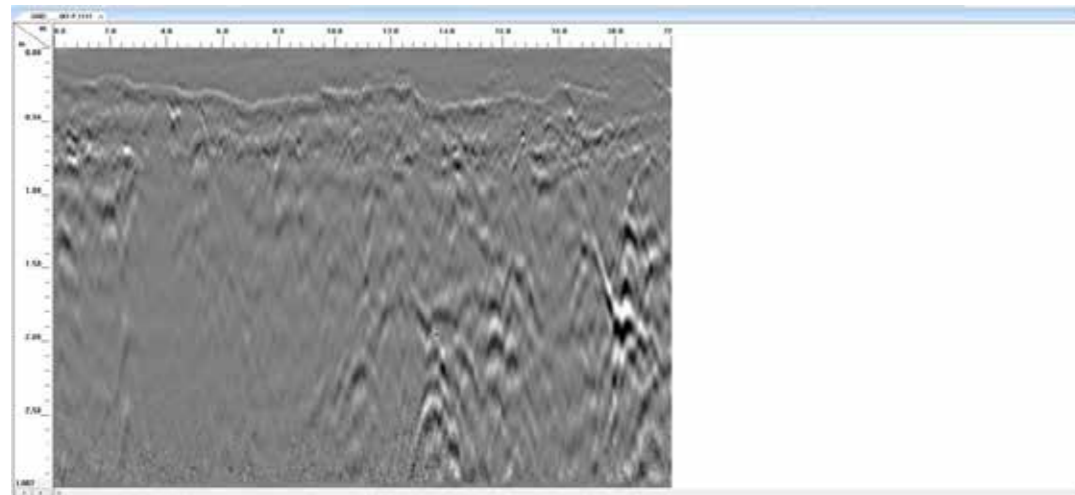
Grid1 starter mark location: LO19: Y:53126.308; X:3755833.981
Grid size:22mx4m
Method of scan: zig zag.
Target ID: **TARGET-G1-2**
Target location: LO19: Y:53133.255; X:3755829.224
Grid slice number: Grid-L002

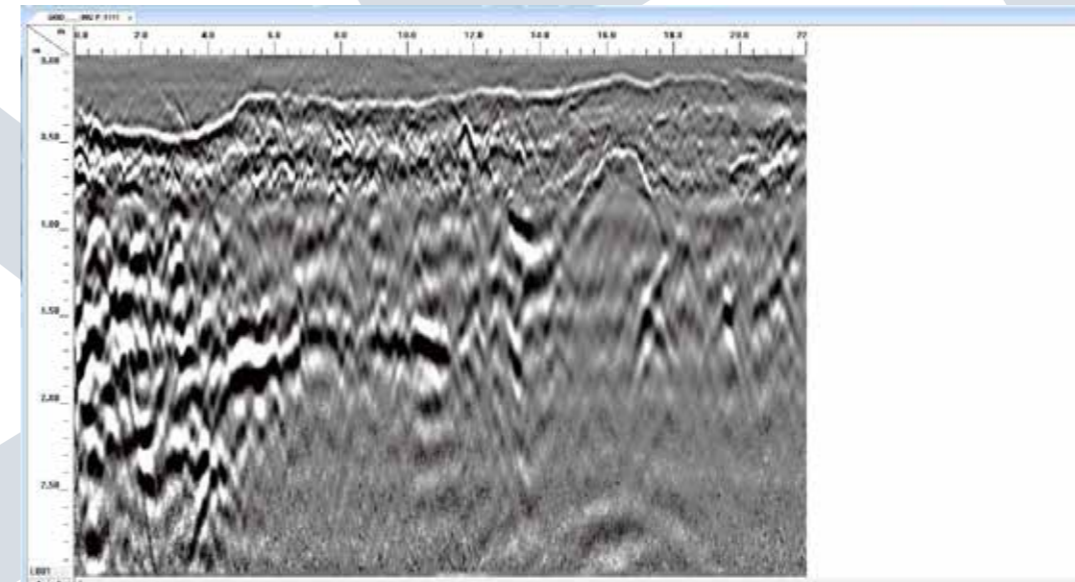
Grid2 starter mark location: LO19: Y: 53129.598; X: 3755837.620
Grid size:22mx4m
Method of scan: zig zag.
Target ID: **TARGET-G2-1**
Target location: LO19: Y:53141.854; X:3755826.870
Grid slice number: Grid2-L001

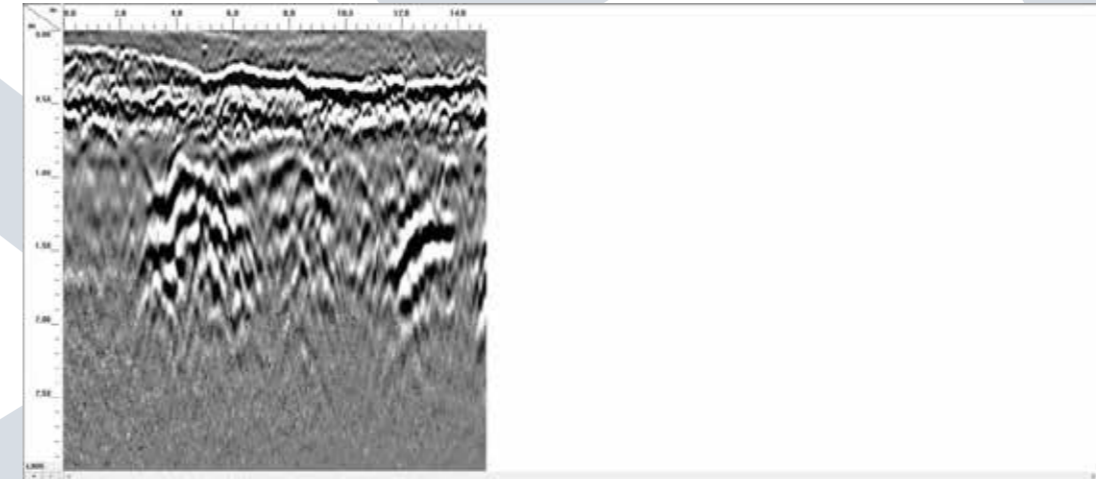
Grid3 starter mark location: LO19: Y: 53133.024; X: 3755841.475
Grid size: 15mx38m
Method of scan: zig zag.
Target ID: **TARGET-G3-1**
Target location: LO19: Y:53141.920; X:3755838.814
Grid slice number: Grid3-L005

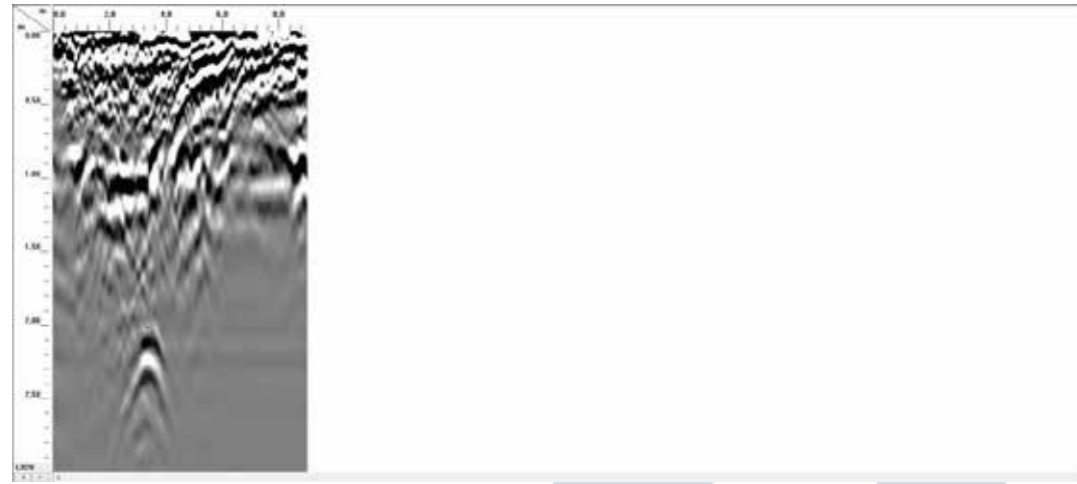
Grid36: TGT-48

Grid36 starter mark location: LO19: Y: 53208.101; X 3755843.175
Grid size: 17mx9m
Method of scan: zig zag.
Target ID: **TARGET-G36-3**
Target location: LO19: Y:53218.610; X:3755841.565
Grid slice number: Grid36-L020

Outcome:

Ground interference detected between 2m to 2.8m deep.
Refer to drawing: DHHO-240612-001 AREA2-REV1.
