APPENDIX C: SITE PHOTOGRAPHS

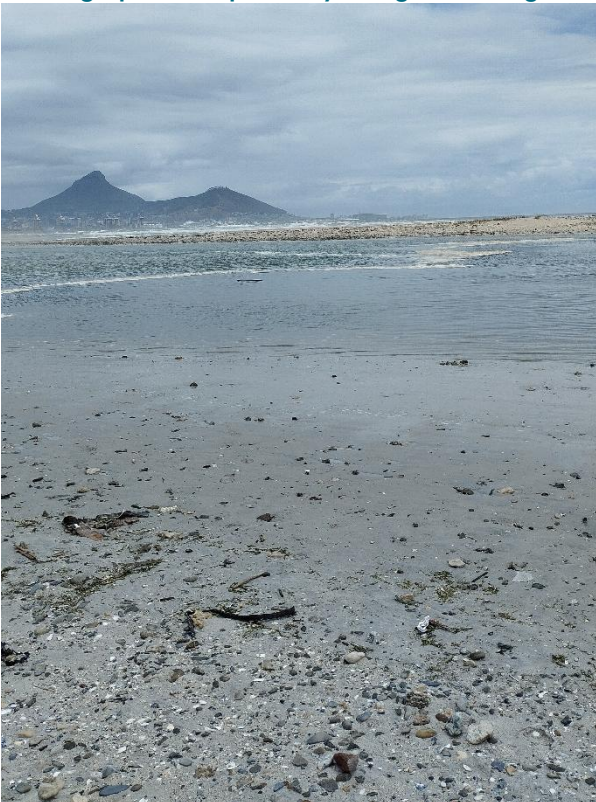
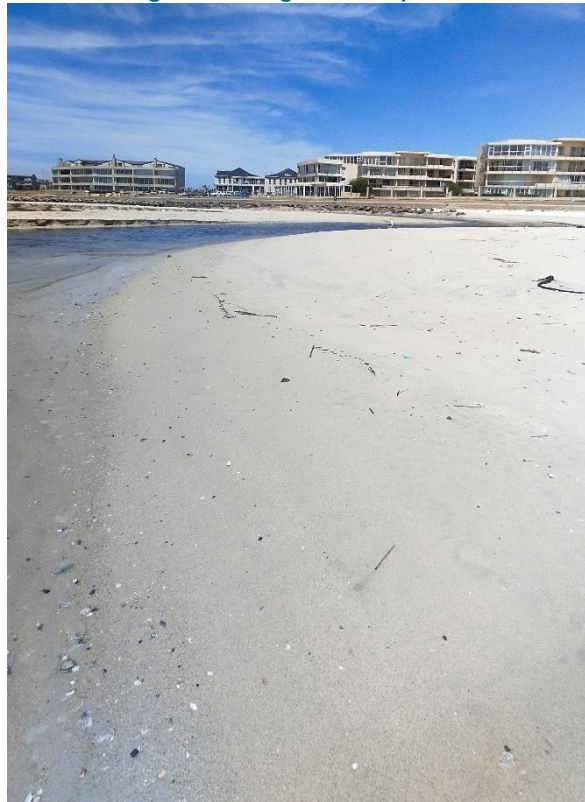
Photographs 6 & 7: The mouth of the Milnerton Lagoon was found to be open to the sea at the time of sampling on 18 December 2024. Photograph 6 was taken facing south-west and image 7 was taken facing south-east towards the apartment and businesses located on the eastern edge of the lagoon.

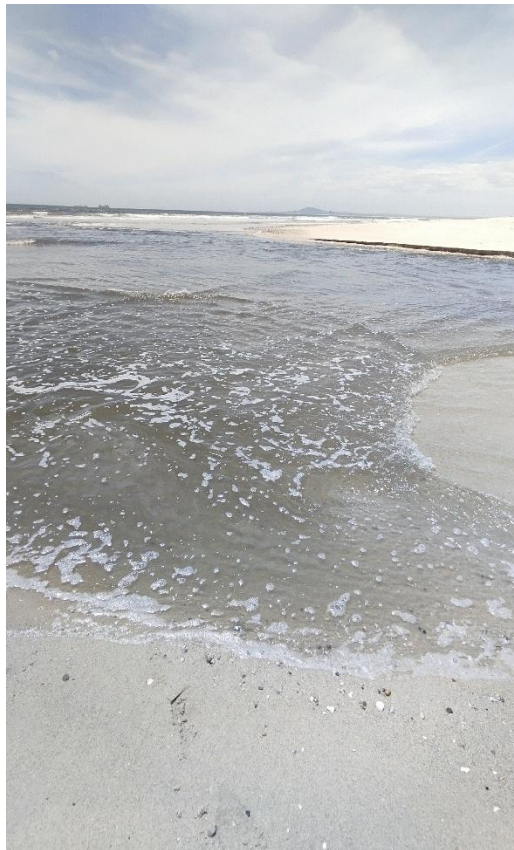
Photograph 8: Intrusion of seawater from Lagoon Beach into the lower estuary can be observed from the image.

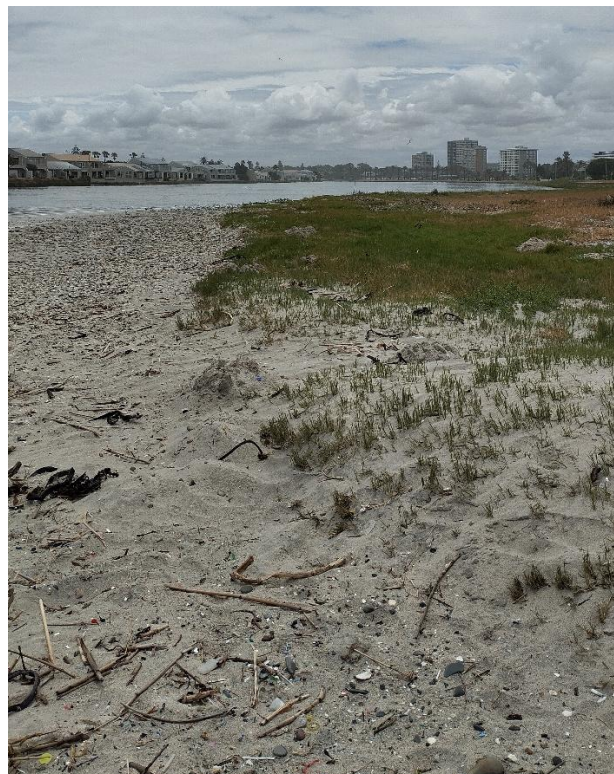
Photograph 9: Natural vegetation persists along the eastern edge of the lagoon near the estuary mouth within the intertidal zone

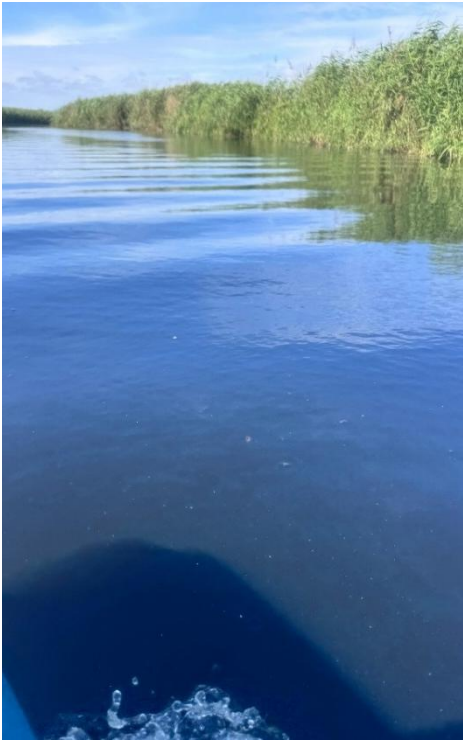
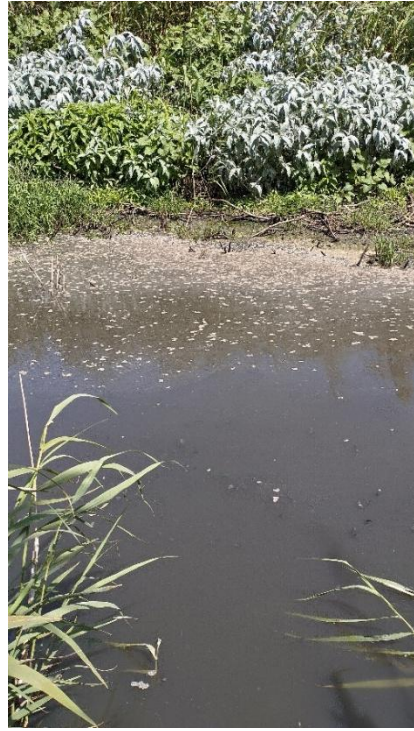
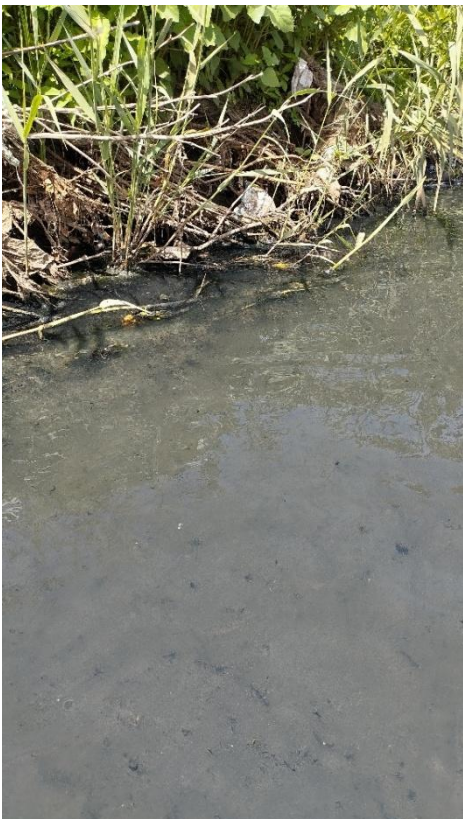
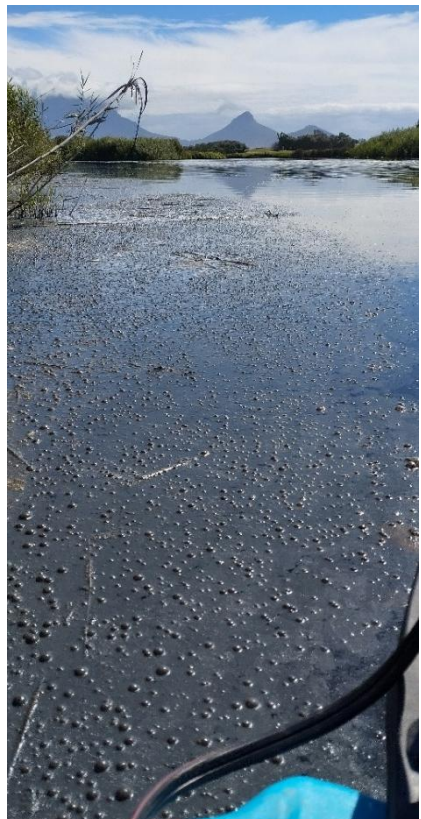
Photograph 11: View beneath the Wooden Bridge displays the discolouration of the water.

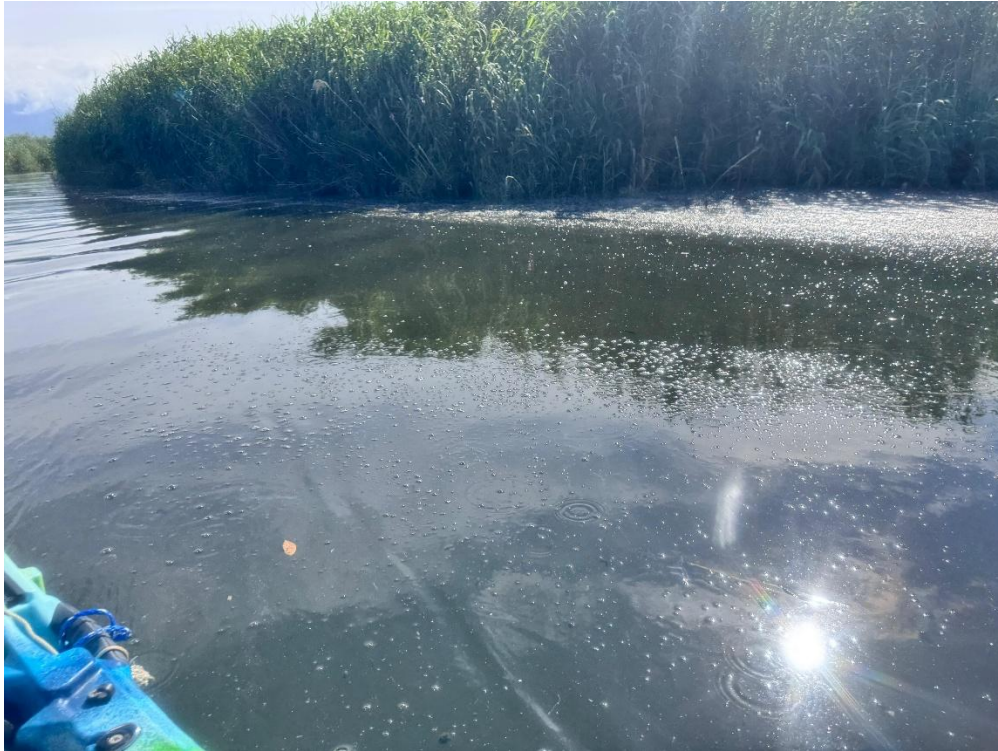
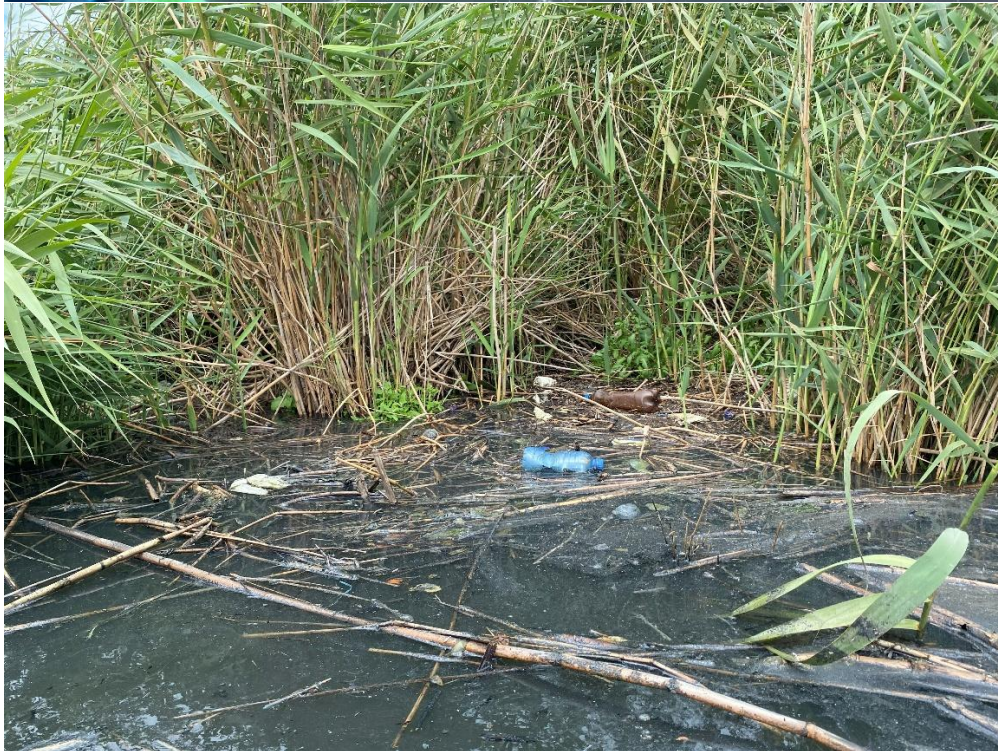
Photographs 12 – 17: The discoloured and polluted state of the water within the lower lagoon, captured upstream of the Loxton Road Bridge, can be observed from these images. The various source points of pollution have markedly impoverished the quality of water within the Milnerton Lagoon flowing through the site.

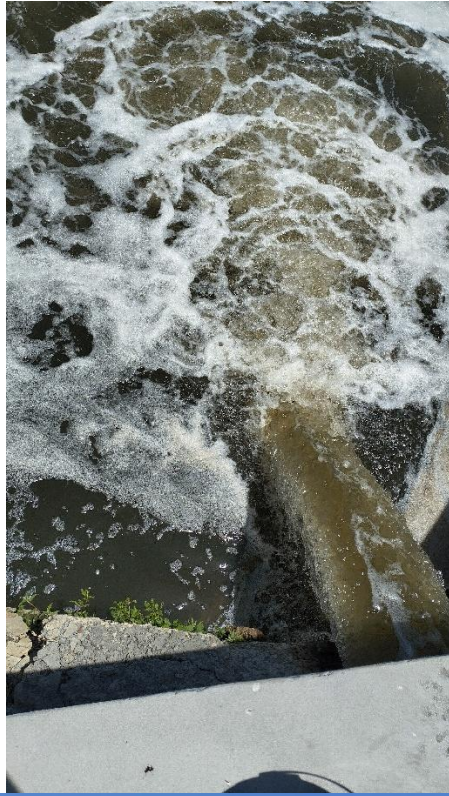
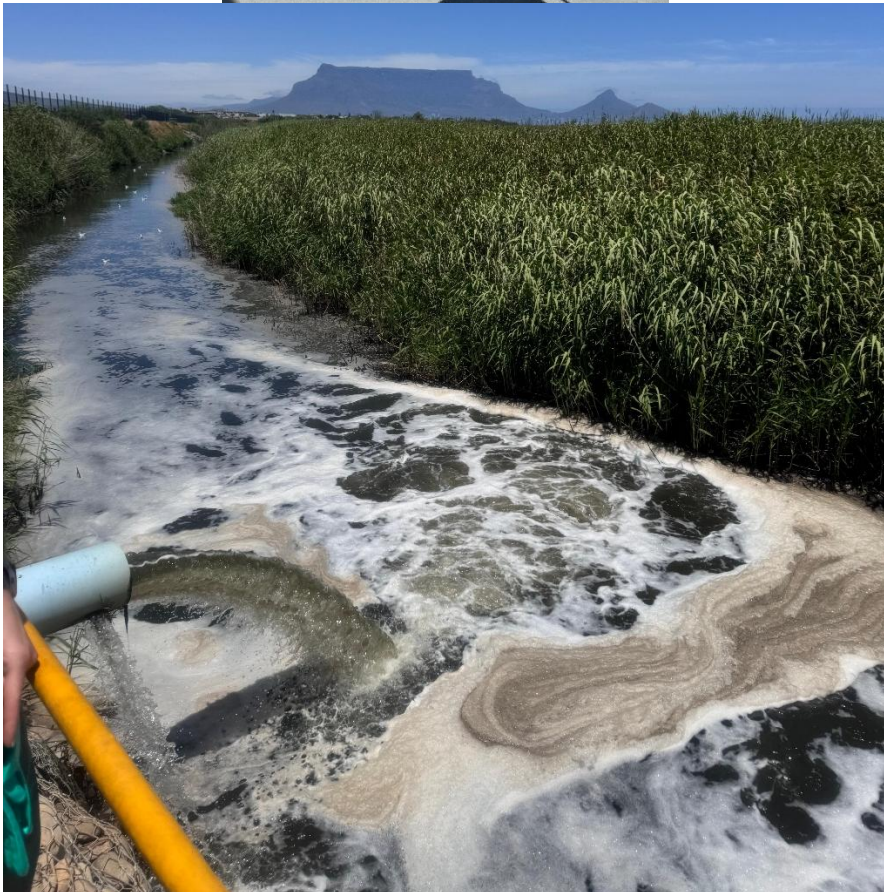
Photographs 18 and 19: Potsdam Waste Water Treatment Works (WWTW) outlet pipes showing discharge of waste water directly into the lagoon.

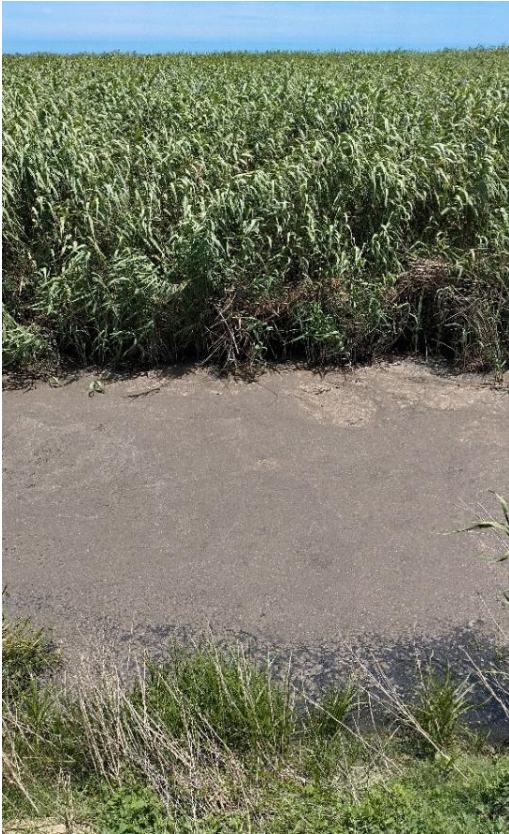
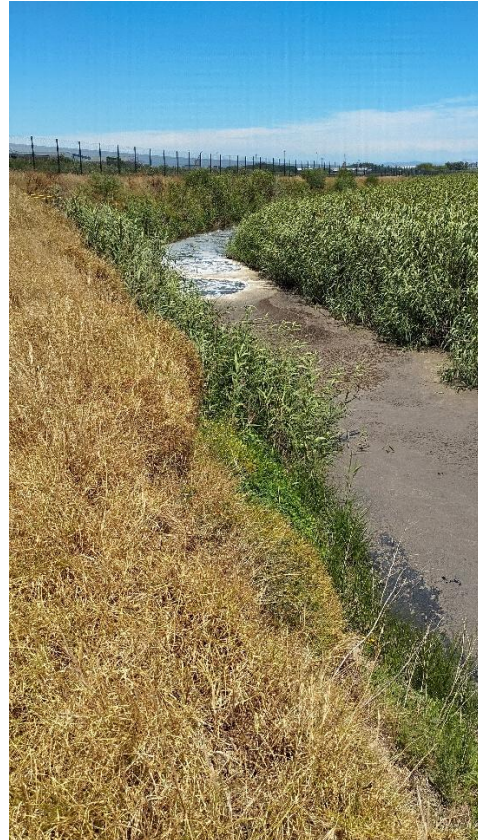
Photographs 20-21: The degraded state of the lagoon water adjacent to the Potsdam WWTW outlet is shown by these images.

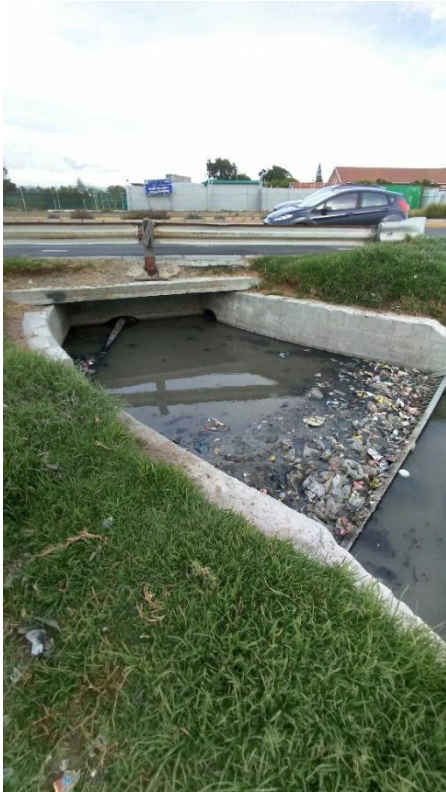
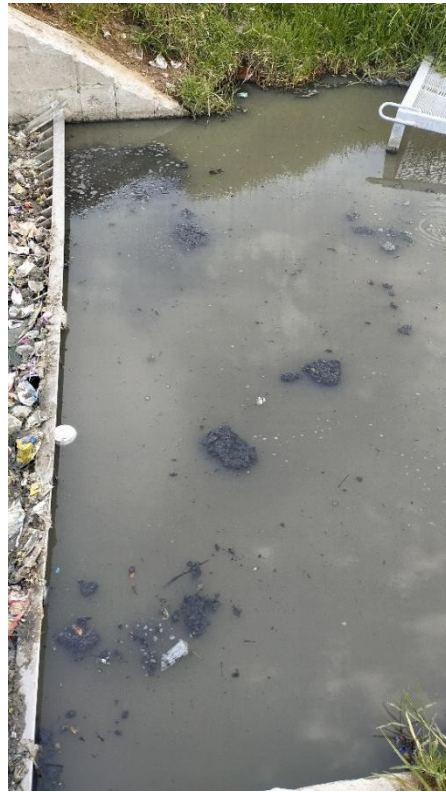
Photographs 22-23: An urban stormwater outlet along the R27 upstream of the site is displayed in this image. Contaminant loads from stormwater runoff of this outlet can be observed.

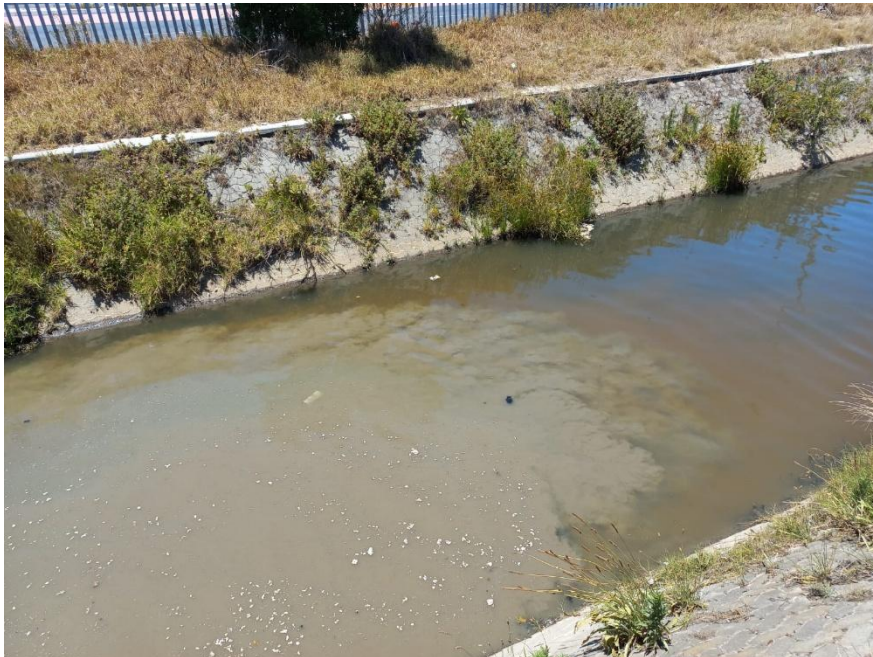
Photograph 24: Pollution loading from the Theo Marais Canal outlet pipe and discharged wastewater (upstream of the site) is pictured in this image.
